Appendix 1

In this Appendix, the photos of the specimens taken after failure are shown in Figure A1.1, Figure A1.3 and Figure A1.5. Moreover, the displacement profiles measured by means of DIC or NDI (or LVDT when no photogrammetry measurements were performed) at the top and bottom fibre at selected load steps are shown in Figure A1.2, Figure A1.4 and Figure A1.6. In the plotted deformed shapes, the rigid body rotation of the beam was corrected in order to have zero vertical displacement at the end support and at the intermediate support (refer to Figure 5.1 for the scheme of the test setup and loading conditions and to Figure 5.2 for the crack pattern at peak load).

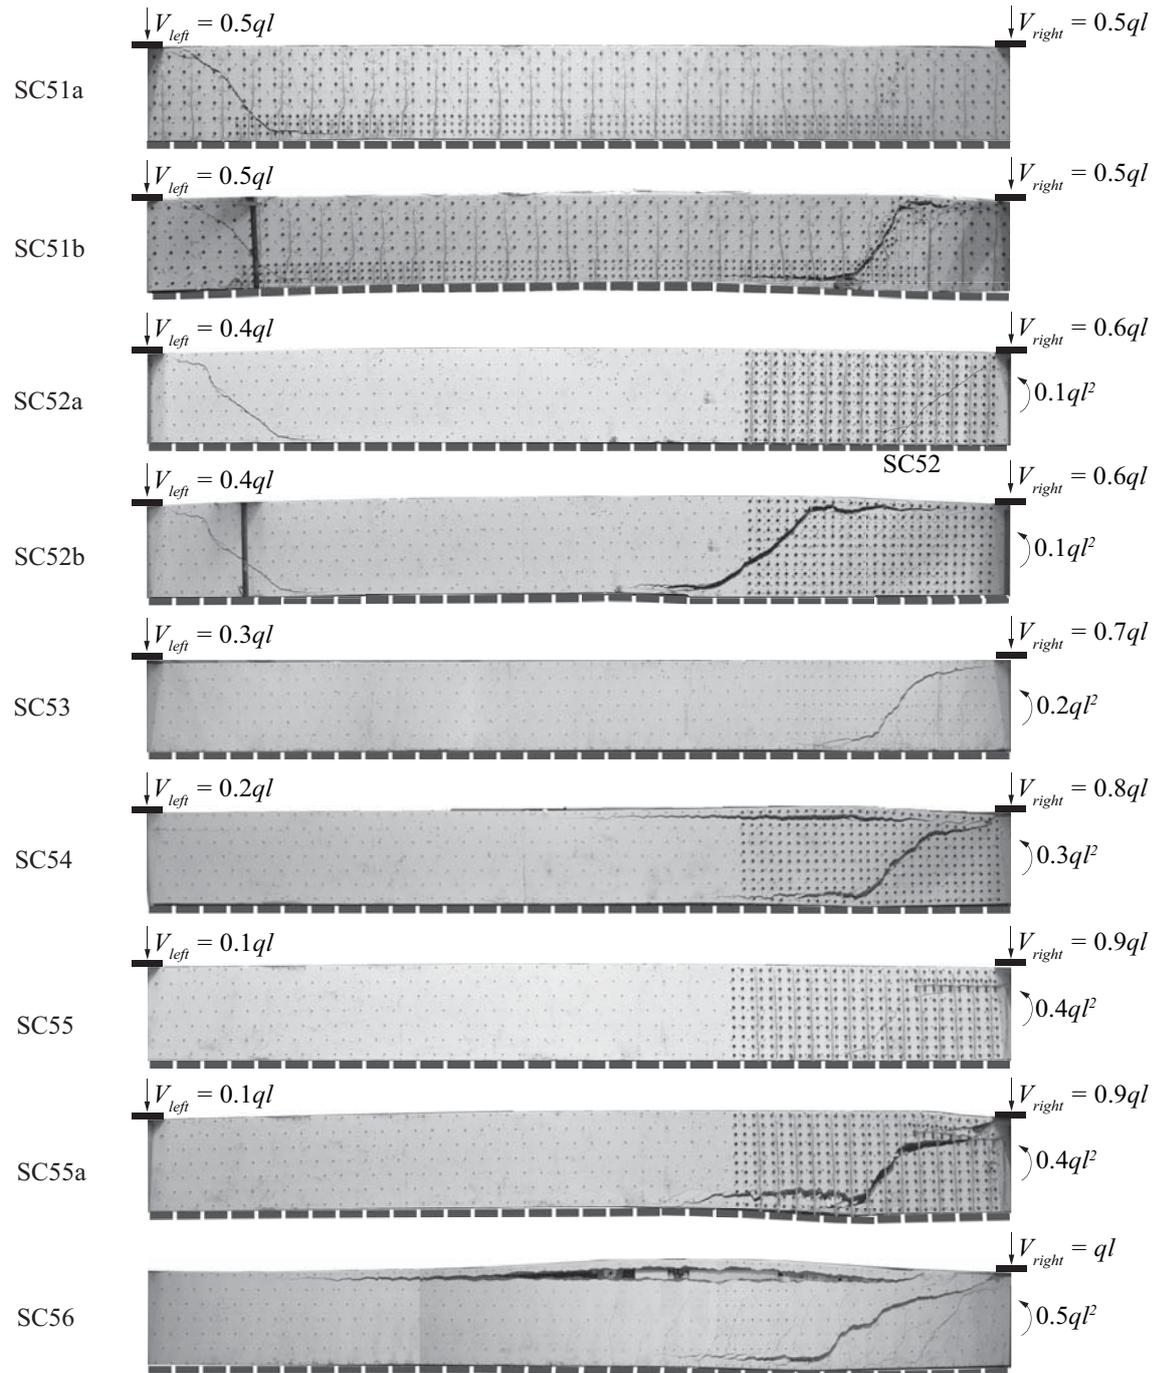
Figure A1.1 Photos of crack pattern after failure: members subjected to distributed loading.

Note that, in specimens SC52, SC55 and SC67, the development of a diagonal crack close to the right support was followed by a drop in the applied load of 5-10%. These specimens however could be reloaded. In specimen SC52a, a shear crack developed close to the left support. The specimen was repaired by means of external plates fixed with prestressed bolts and retested: a second failure crack developed close to the point of contraflexure (SC52b, see Figure A1.1). In specimens SC55a and SC67a, a direct strut action developed in the uncracked compression zone above the critical shear crack and failure occurred due to crushing of the compression zone (see respectively Figure A1.1 and Figure A1.5).

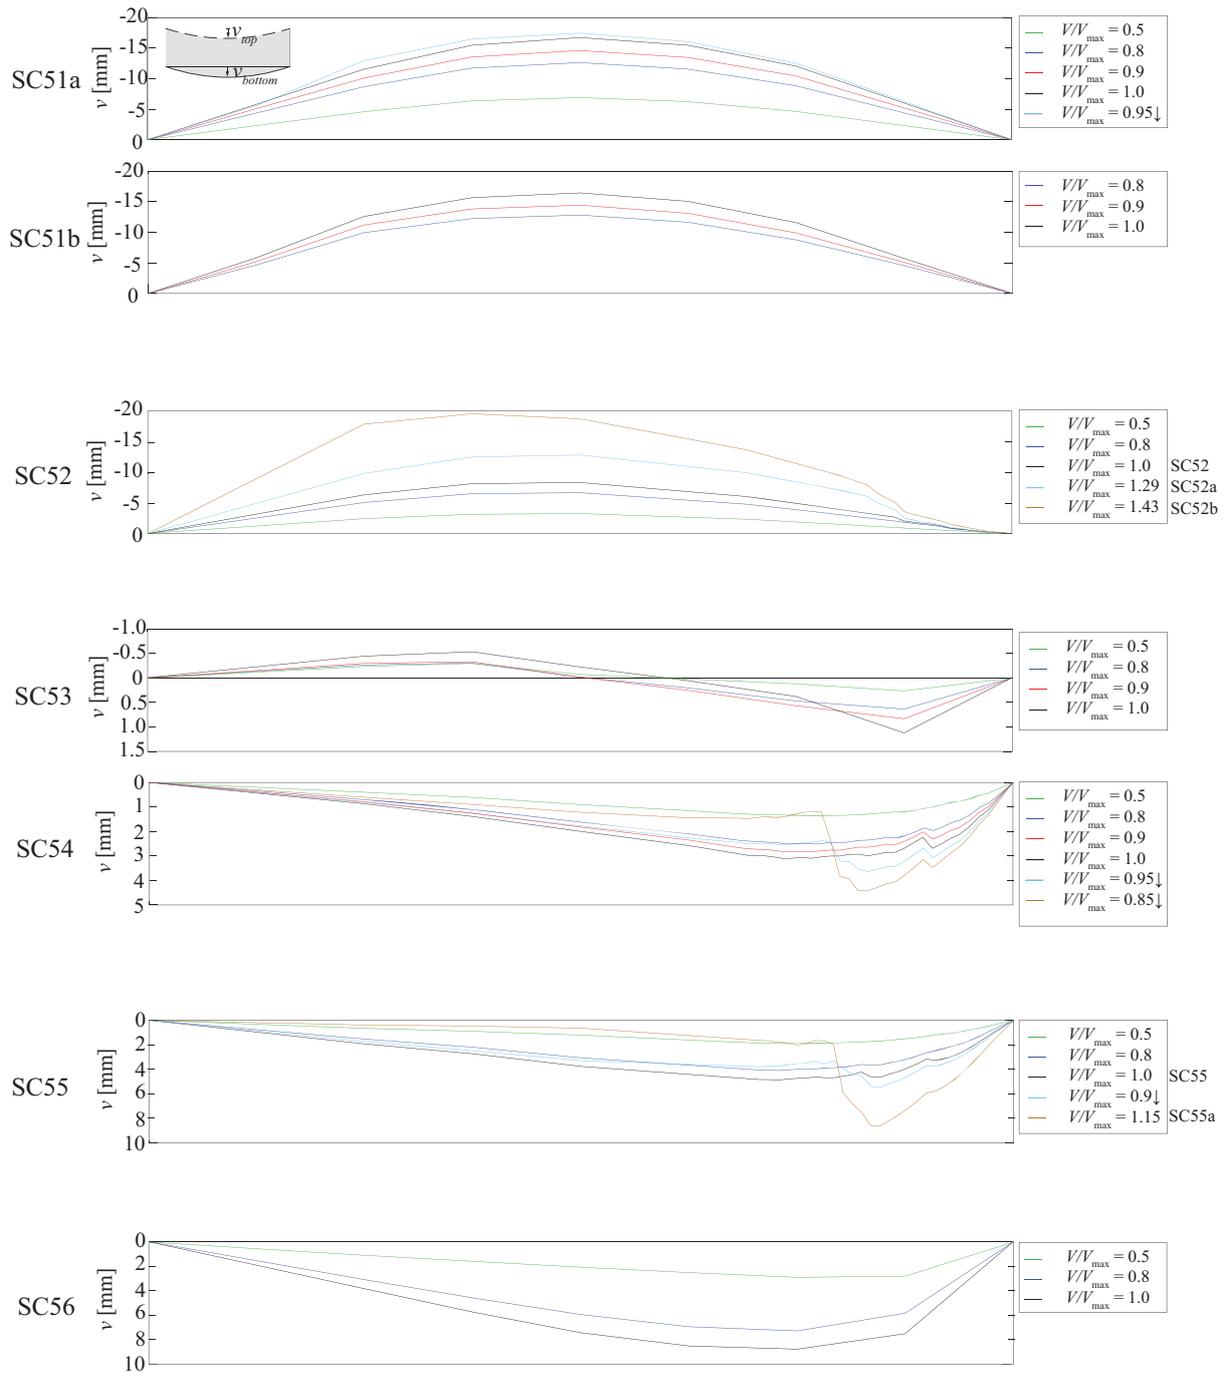
Figure A1.2 Members subjected to distributed loading: vertical displacement profile of bottom fibre at selected load steps (continuous lines).

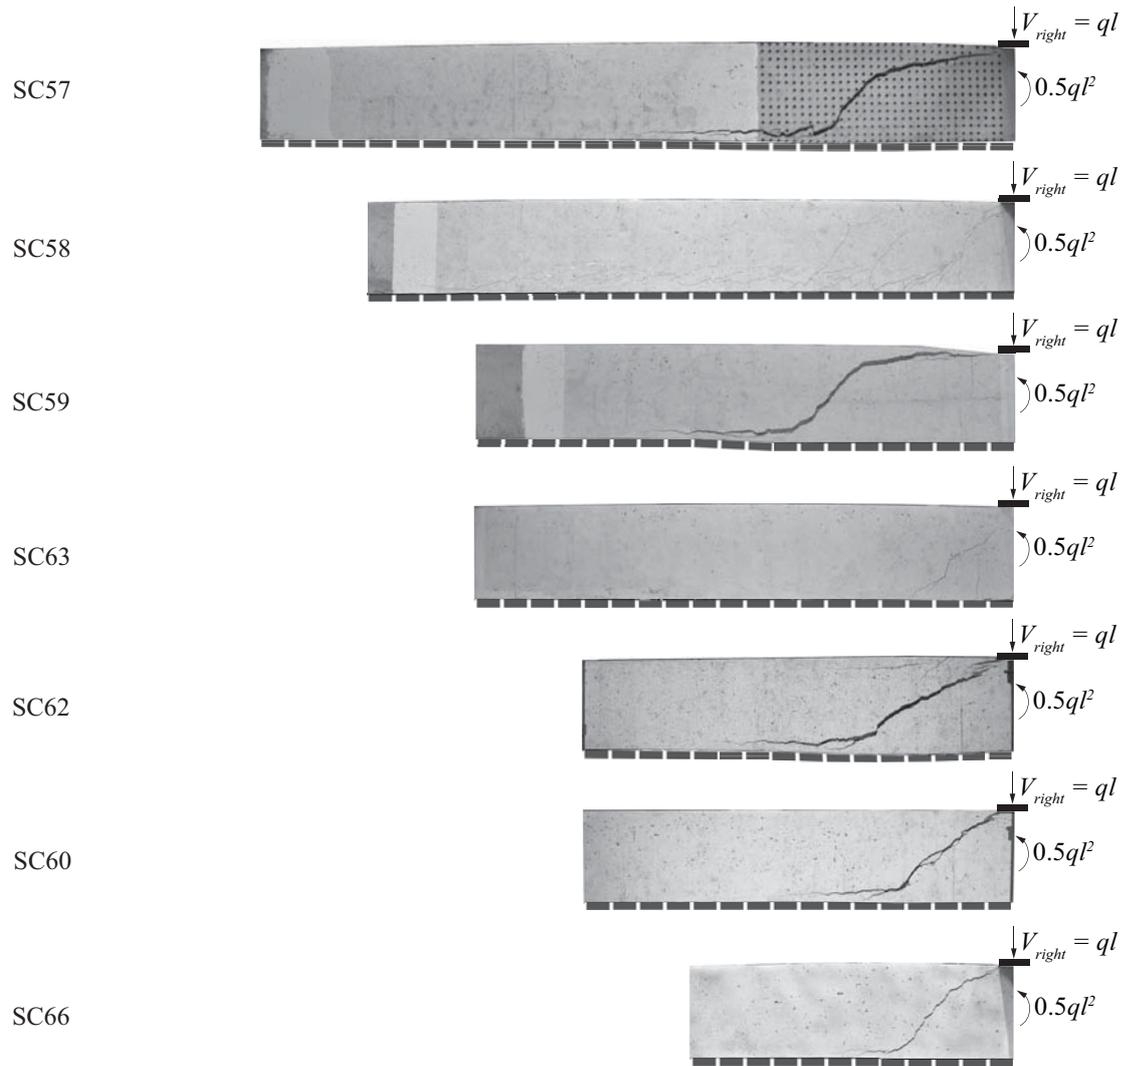
Figure A1.3 Photos of crack pattern after failure: cantilevers subjected to distributed loading

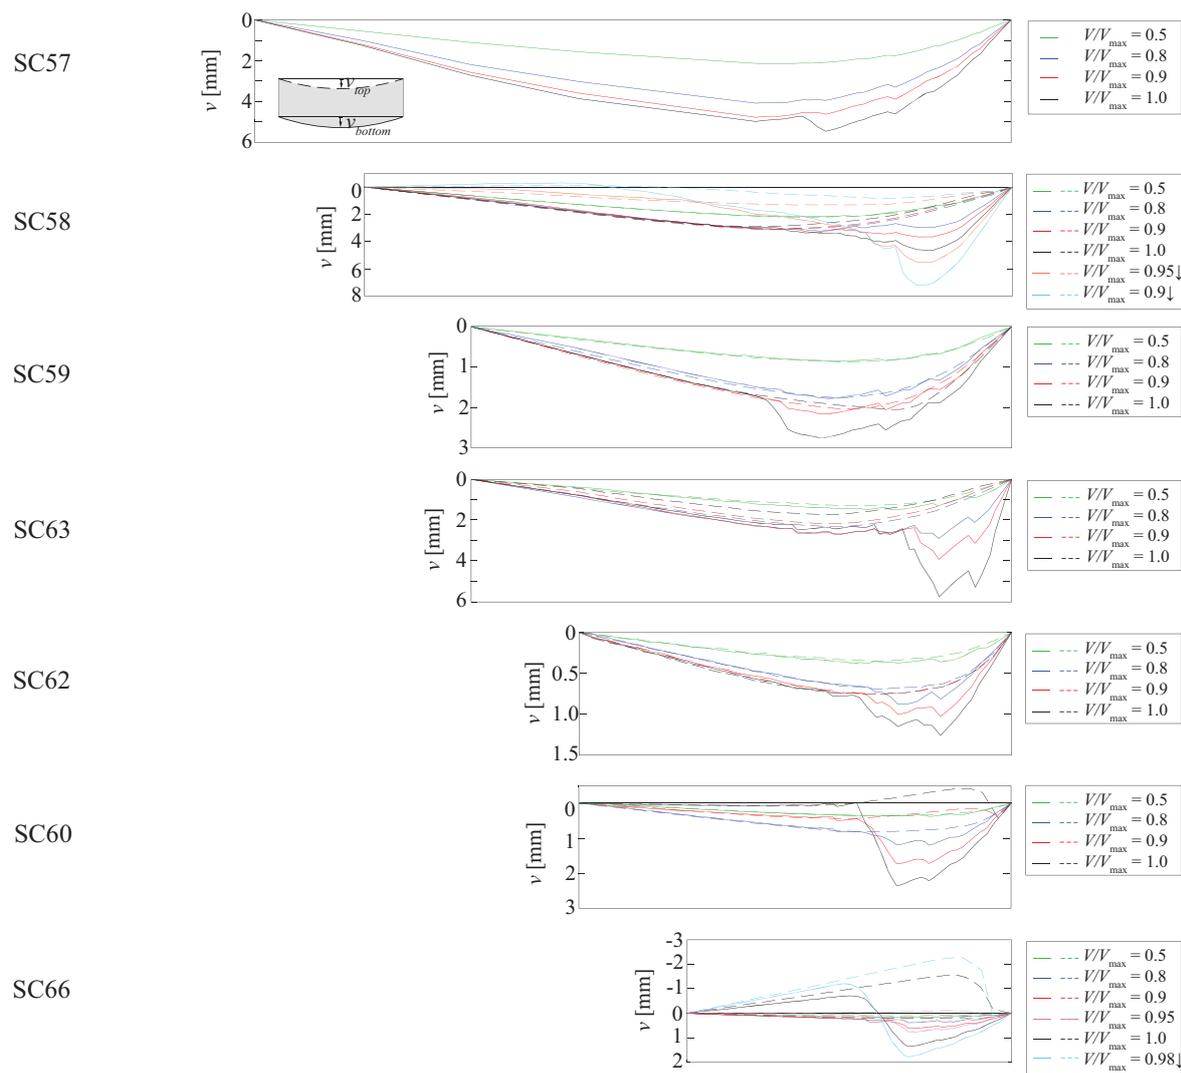
Figure A1.4 Cantilevers subjected to distributed loading: vertical displacement profile of top fibre (dashed lines) and vertical displacement profile of bottom fibre (continuous lines) at selected load steps.

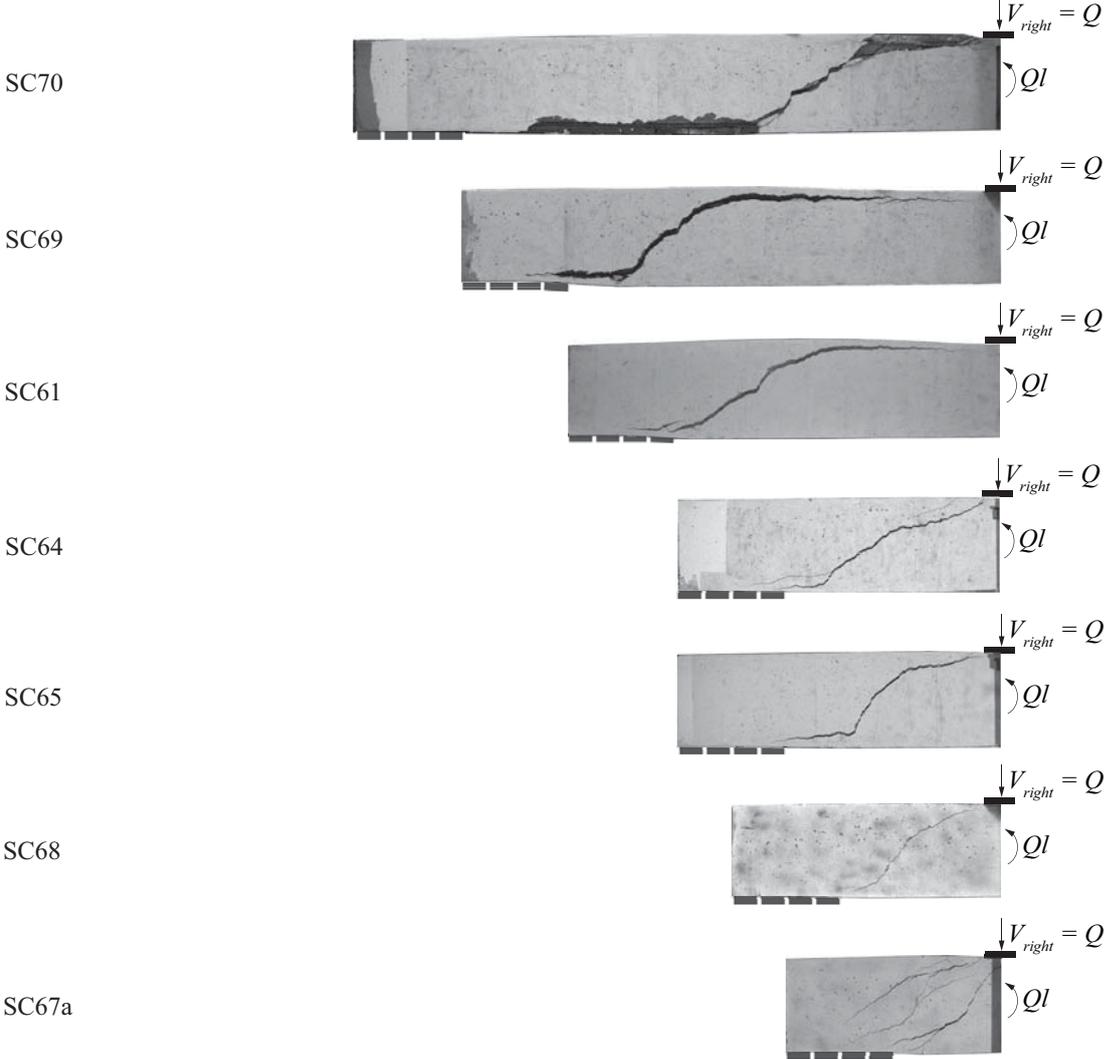
Figure A1.5 Photos of crack pattern after failure: cantilevers subjected to point loading.

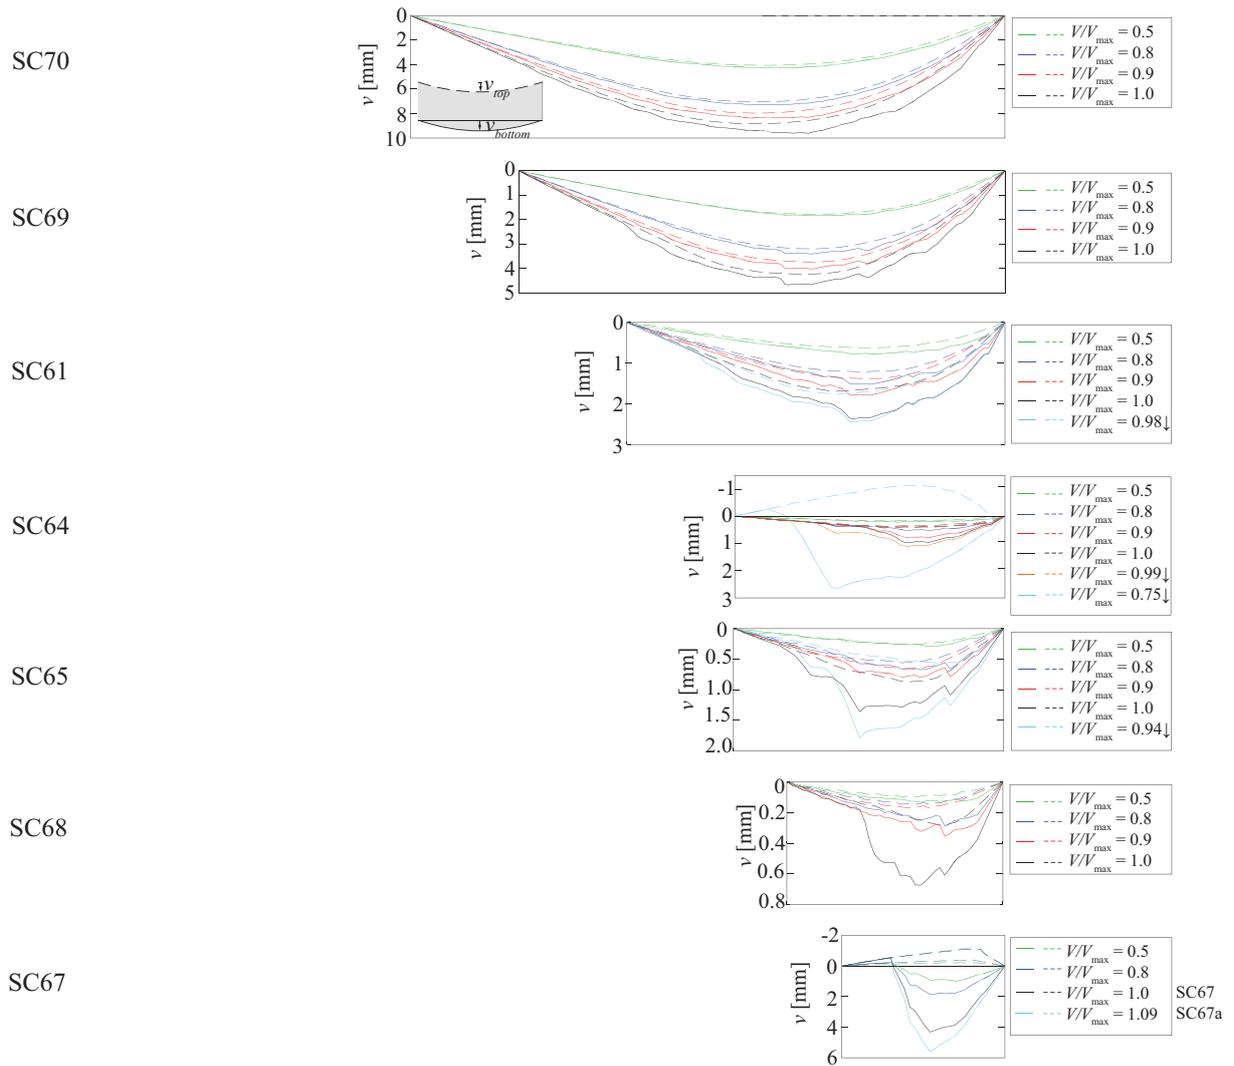
Figure A1.6 Specimens subjected to point loading: vertical displacement profile of top fibre (dashed lines) and vertical displacement profile of bottom fibre (continuous lines) at selected load steps.
